west virginia department of environmental remediation
Office of Environmental Remediation

VRP Project #: **15017**
Brownfield Site: Yes ☐ No ☒
Report Date: **3-9-16**
Page **1** of **6**

OFFICE OF ENVIRONMENTAL REMEDIATION
VOLUNTARY REMEDIATION PROJECT
SITE VISIT/INSPECTION REPORT

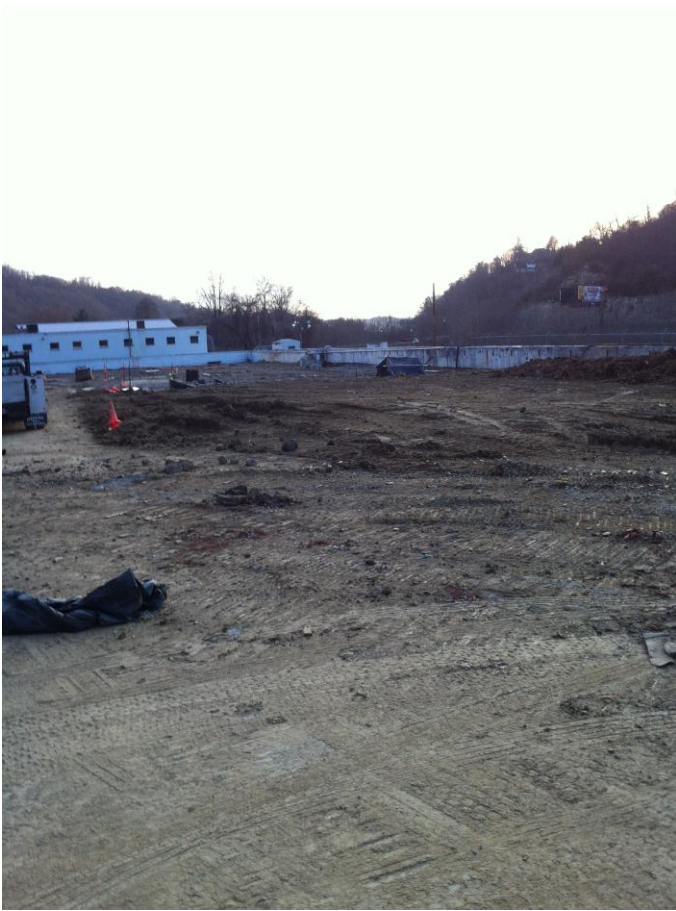
3. Dozer grading slope which now reaches into Area 3.
4. Dozer positioning boulder to aid in slope stability.
5. Heavy equipment working in Areas 3 & 4.
6. View of modified slope - looking southwest.
7. Dozer spreading clay capping material in upper portion of slope in Area 3.
8. Close-up of area where gas line valve was damaged.
9. Excess material from slope grading was spread in Area 1A.
10. View of slope looking northeast from collection trench area.
11. View of slope looking southeast from collection trench area.
12. Excavator working on slope - looking south.
13. Trench area at toe of slope.
14. View from lower level looking northeast towards slope area.
15. Repair crew working to stop gas leak.
